RE: Eddystone Hotel – Request for Rehabilitation Concept Approval 100 Sproat Street, at the northwest corner of Sproat and Park Avenue

THE EDDYSTONE

SUBMITTAL FOR CONCEPT APPROVAL 04/21/2015

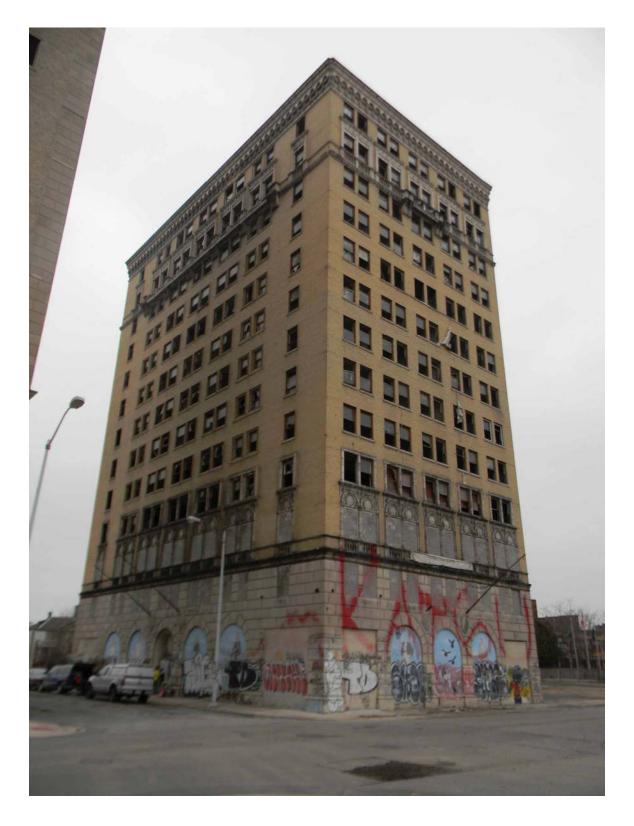
Figure #1: Exterior, Primary Facades, SE Corner of Building. 11/26/14.

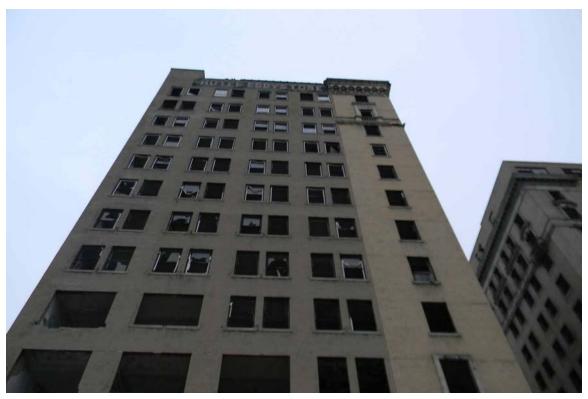
Figure #2: Exterior, Secondary West Façade on Alley. 11/26/14.

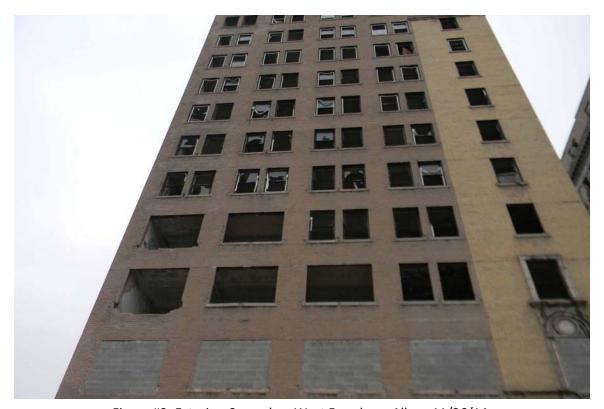
Figure #3: Exterior, Secondary West Façade on Alley. 11/26/14.

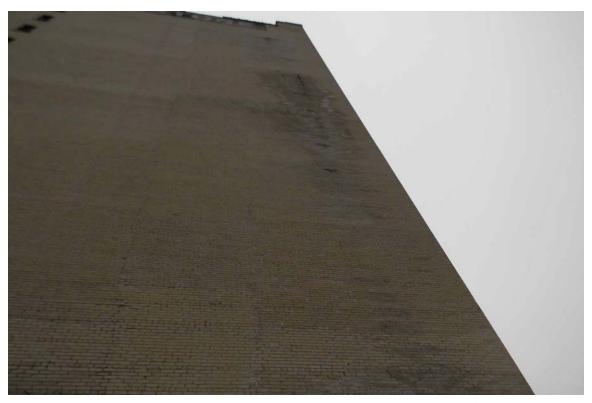
Figure #4: Exterior, Secondary North Façade at rear of building. 11/26/14.

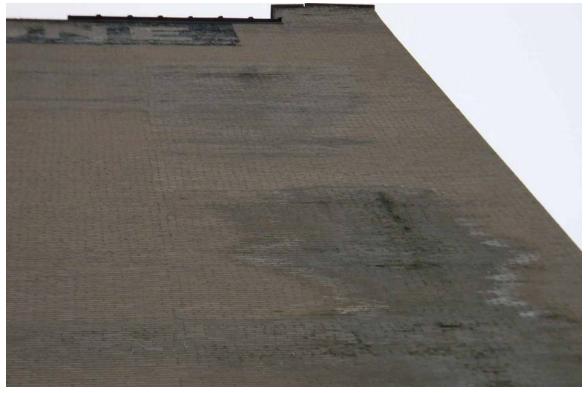
Figure #5: Exterior, Secondary North Façade, close up view of masonry damage. 11/26/14.

The Owner proposes to fully rehabilitate all areas of damaged masonry. All sound existing materials will be cleaned using the gentlest means possible, and in accordance with the National Park Service preservation brief guidelines. Missing or damaged bricks will be replaced in kind. New mortar will match the existing in color, texture, strength, and

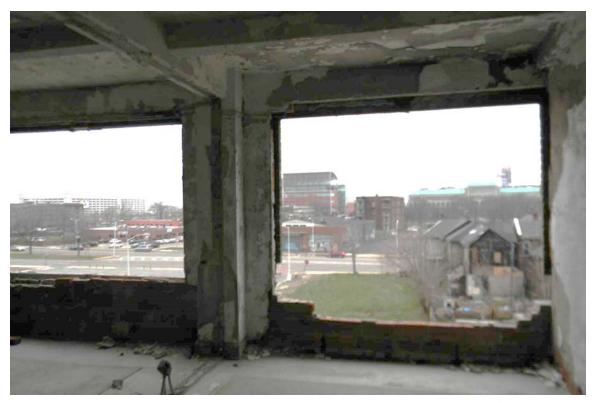
Figure #6: Floor 4, View of large windows at NW corner, Looking West. 11/26/14.

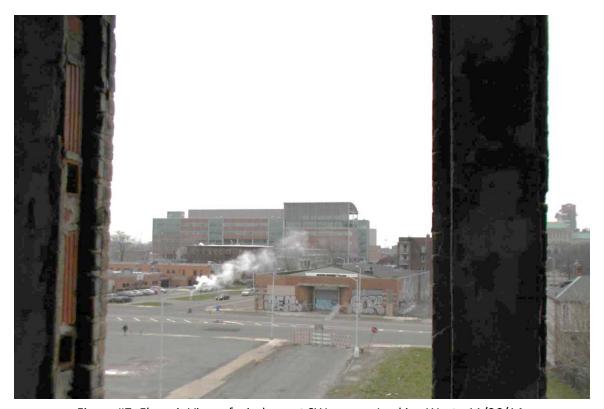
Figure #7: Floor 4, View of windows at SW corner, Looking West. 11/26/14.

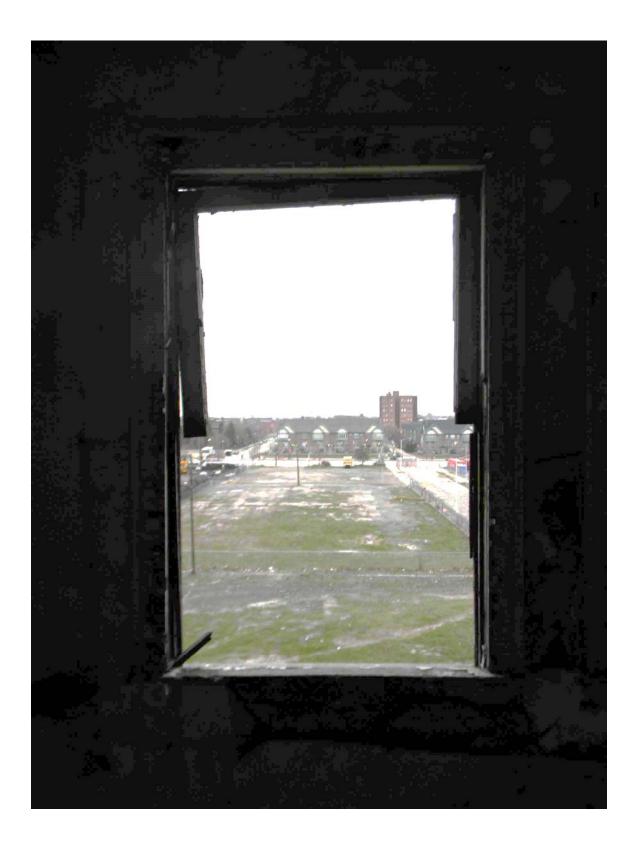
Figure #8: Floor 5, View window at east facade, Looking East. 11/26/14.

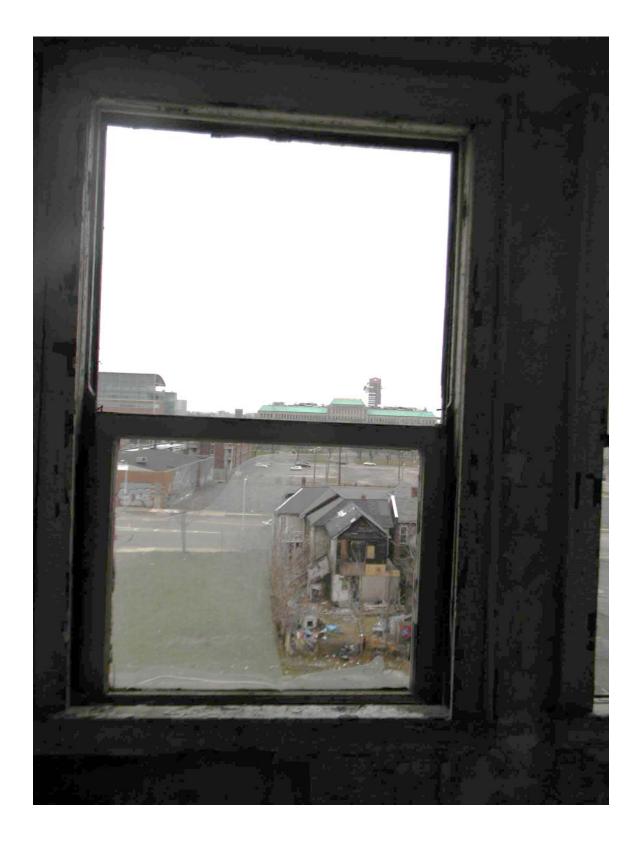
Figure #9: Floor 5, View window at west façade, Looking West. 11/26/14. Lower sash is missing; Upper sash has dropped down

The Owner proposes to replace all windows with historic replica aluminum windows in accordance with *NPS Preservation Brief 9 – Window Replacement Guidelines*. In circumstances such as exist here, Brief 9 permits replacement windows if they match (i) the appearance, size, design, proportions, profiles, and sightlines of the existing historic windows, (ii) the existing window position in the wall, and (iii) the dimensions of the individual elements including head, sill, panes, jambs, sash, and overall depth. A Traco TR-9700 or approved historic replica alternate from another manufacturer will be used here, with custom profiles created where necessary to replicate the historic profiles to within a ¼" tolerance of the historic windows. The window finish will complement the historic character of the building, and will be an anodized medium bronze finish or a similar painted color. Glazing will be clear glass with an applied low-e coating for maximum visible light transmittance. Final details of the proposed windows and window finishes will be provided to HDC for final approval when available from the manufacturer.

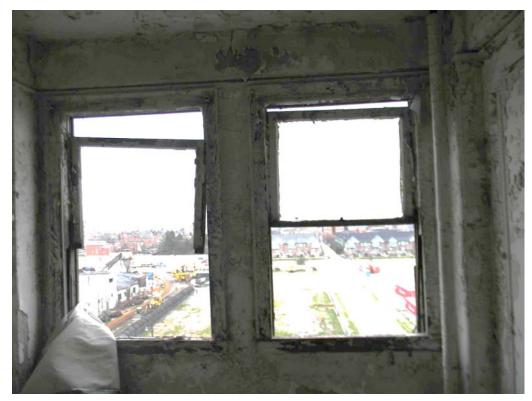
Figure #10: Floor 5, View of windows at east facade, Looking East. 11/26/14. Lower sashes are missing. Upper sashes are severely damaged and missing glazing and sash components

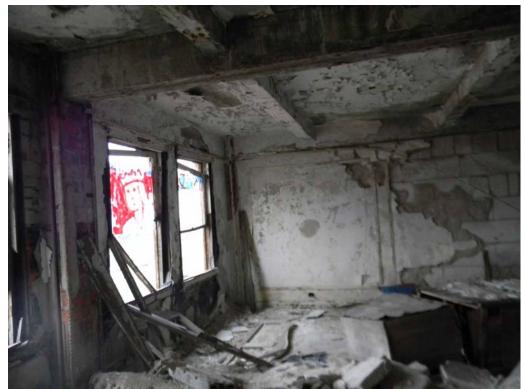
Figure #11: Floor 11, View of windows at S facade, Looking SW. 11/26/14. Lower sashes are missing. Upper sashes are severely damaged with missing glazing and sash components

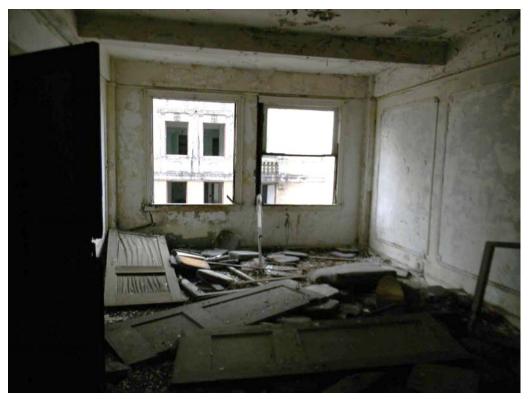
Figure #12: Floor 11, View of windows at South facade, Looking South. 11/26/14.

Multiple sashes are missing. Upper sash is severely damaged.

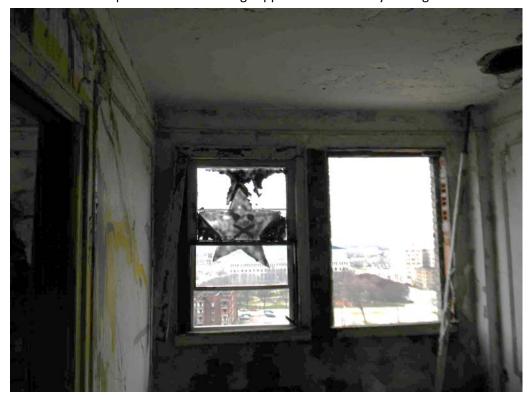
Figure #13: Floor 11, View of windows at West facade, Looking West. 11/26/14. Window on right has been completely removed, including all frame components

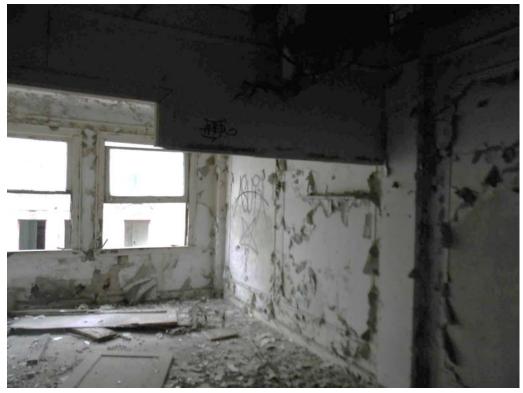
Figure #14: Floor 12, View of windows at South facade, Looking South. 11/26/14. Lower sashes are missing. Upper sashes are severely damaged.

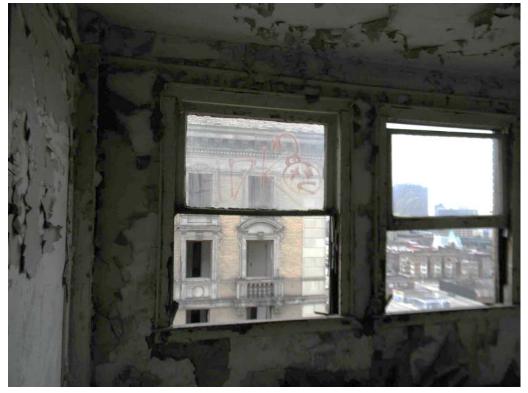
Figure #15: Floor 12, View of windows at S facade, Close up. 11/26/14. Remaining frame components and balance pockets are in very poor condition.

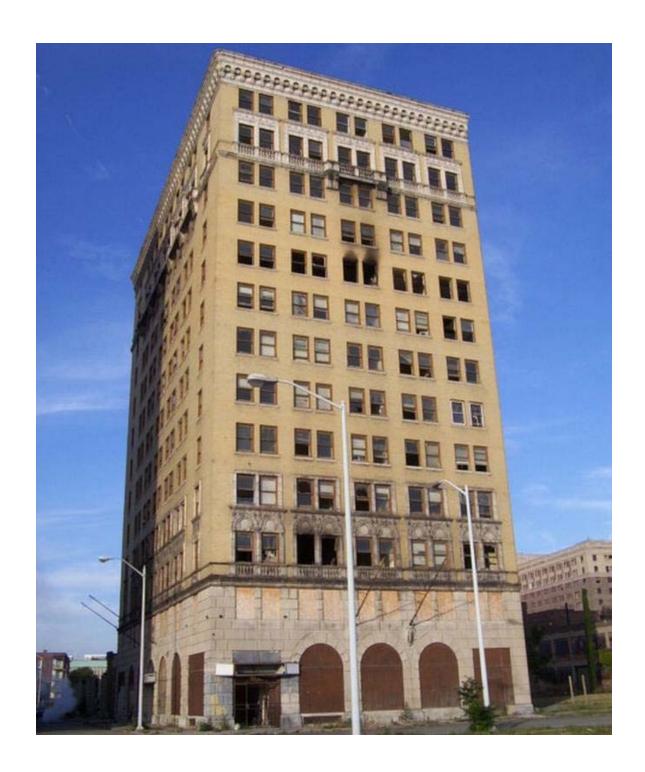
Figure #16: Exterior, East Facade, Photo taken in 2001 prior to current ownership.
